NATIONAL TRAILS HIGHWAY 66 HISTORIC BRIDGE PRESERVATION PROGRAM

DOLA AND LANZIT BRIDGES PILOT REPLACEMENT PROJECT PHOTO NARRATIVE

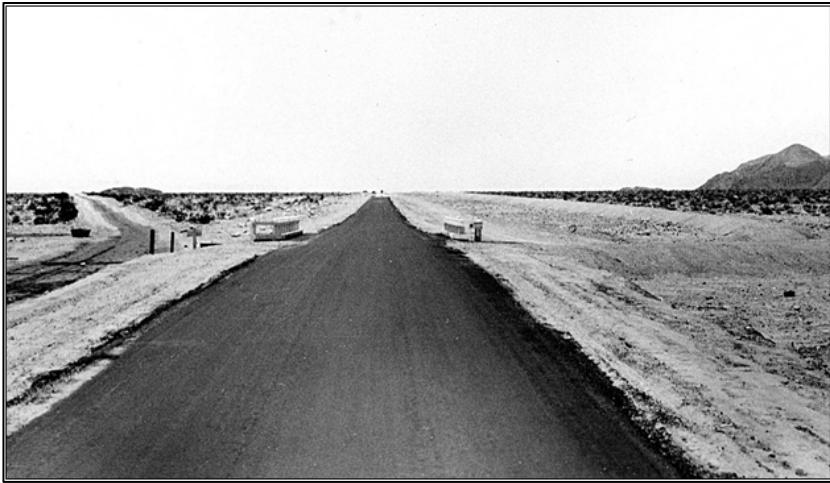
View: Historic 1931 photograph showing newly built Dola Ditch Bridge on new 1931 realigned Route 66, and original U.S. Highway 66 alignment angling off to image left looking westerly. Note the wood posts extending above the guardrail. Timber automobile highway bridges were common across the United States beginning just after the turn-of-the-century, and extending into the 1930s.

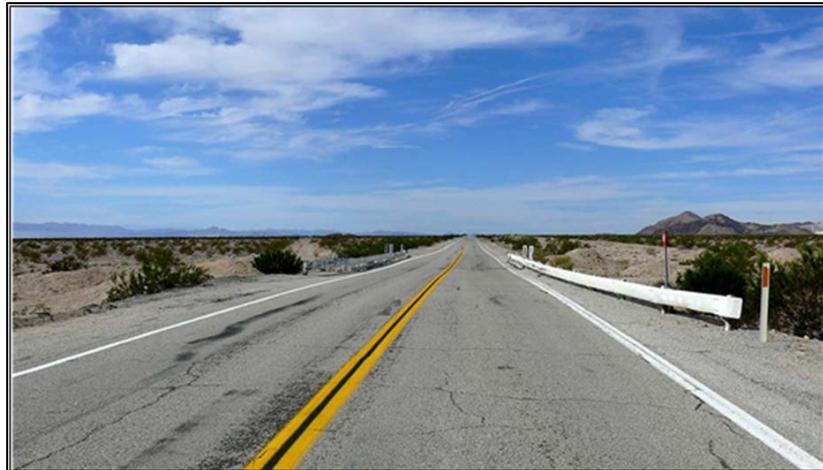
View: Dola Ditch Bridge before construction showing existing CA Highway 66/NTH alignment (1931-Present) and Original U. S. Highway 66 alignment (1926-1931) cutting-off to image left. Note the cut-down bridge wood posts, and long added "C" type metal guardrails impacting the historic view.

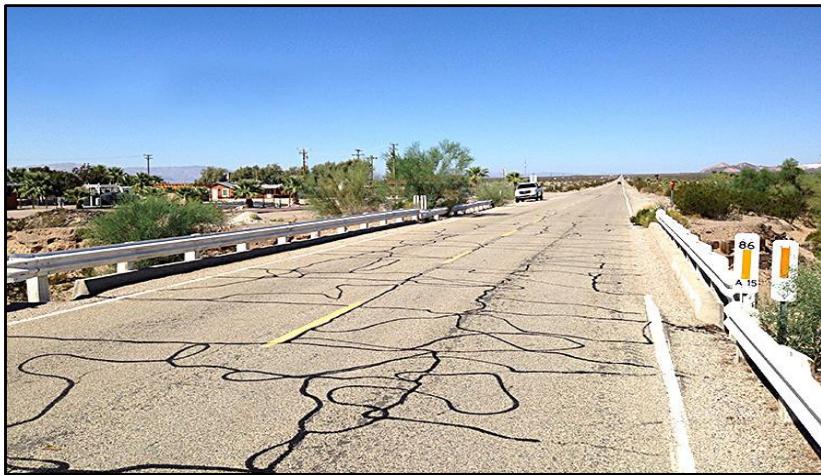
View: Depicting how the original bridge wood railings have been removed, the original wood posts cut down reduced in height, and how the wood curbs with scuppers have been modified by the addition of concrete curbs. In effect, this bridge no longer reads clearly as an historic timber trestle structure. Rather, it reads as a highly modified bridge lacking historic integrity.

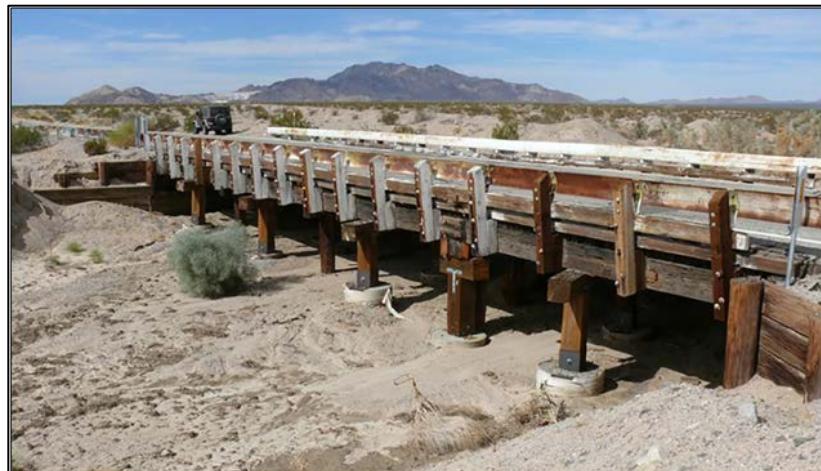
View: This Pre-Construction photograph of Lanzit Ditch Bridge shows an entirely new set of pilings or bents and beams placed on sonotubes. These sonotubes have been placed underneath many NTH bridges as a means of supporting aging structures, representing a major alteration to the original timber trestle design including utilizing a new engineering concept, construction techniques, and overall visual aesthetic and appearance.

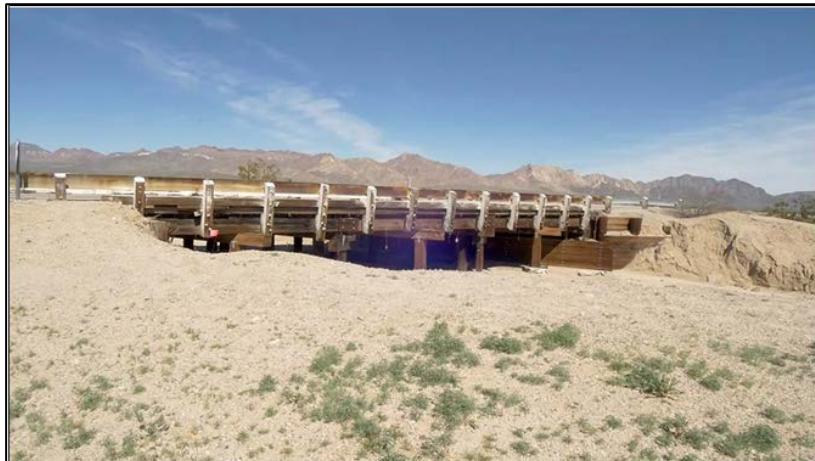
View: The change in the visual appearance and character of the historic bridge guardrail versus the existing metal guardrail. The existing metal guardrail is approximately two-thirds the height of the original wooden guardrail, creating a virtually straight line across the length of the bridge.

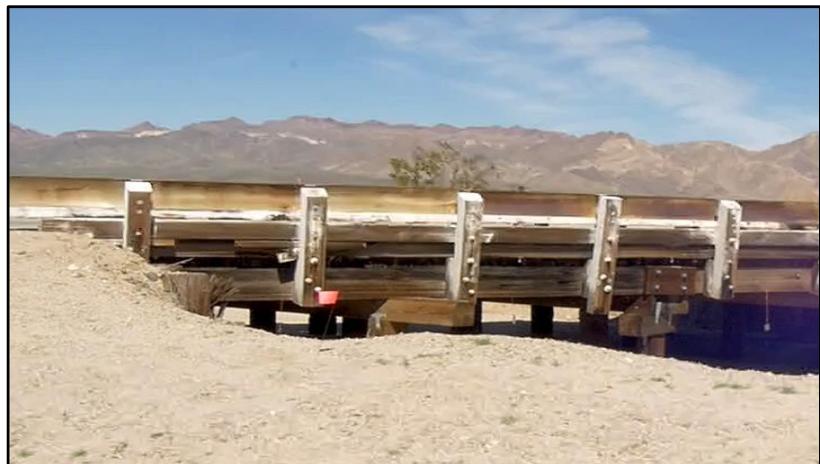
View: This Pre-Construction view of Lanzit Ditch Bridge clearly shows radical change in the visual appearance and character of the historic 1931 bridge guardrail versus the existing Pre-Construction metal guardrail. All NTH/Route 66 bridges were historically modified to a greater or lesser degree
