Efficient and Sustainable Bridge Maintenance, Construction and Reconstruction Projects

REPLACING THE HICKMAN ROAD BRIDGE

CONNECTING COMMUNITIES, PRESERVING A CRITICAL REGIONAL ROAD SYSTEM, AND PROVIDING POSITIVE EFFECTS TO THE ENVIRONMENT

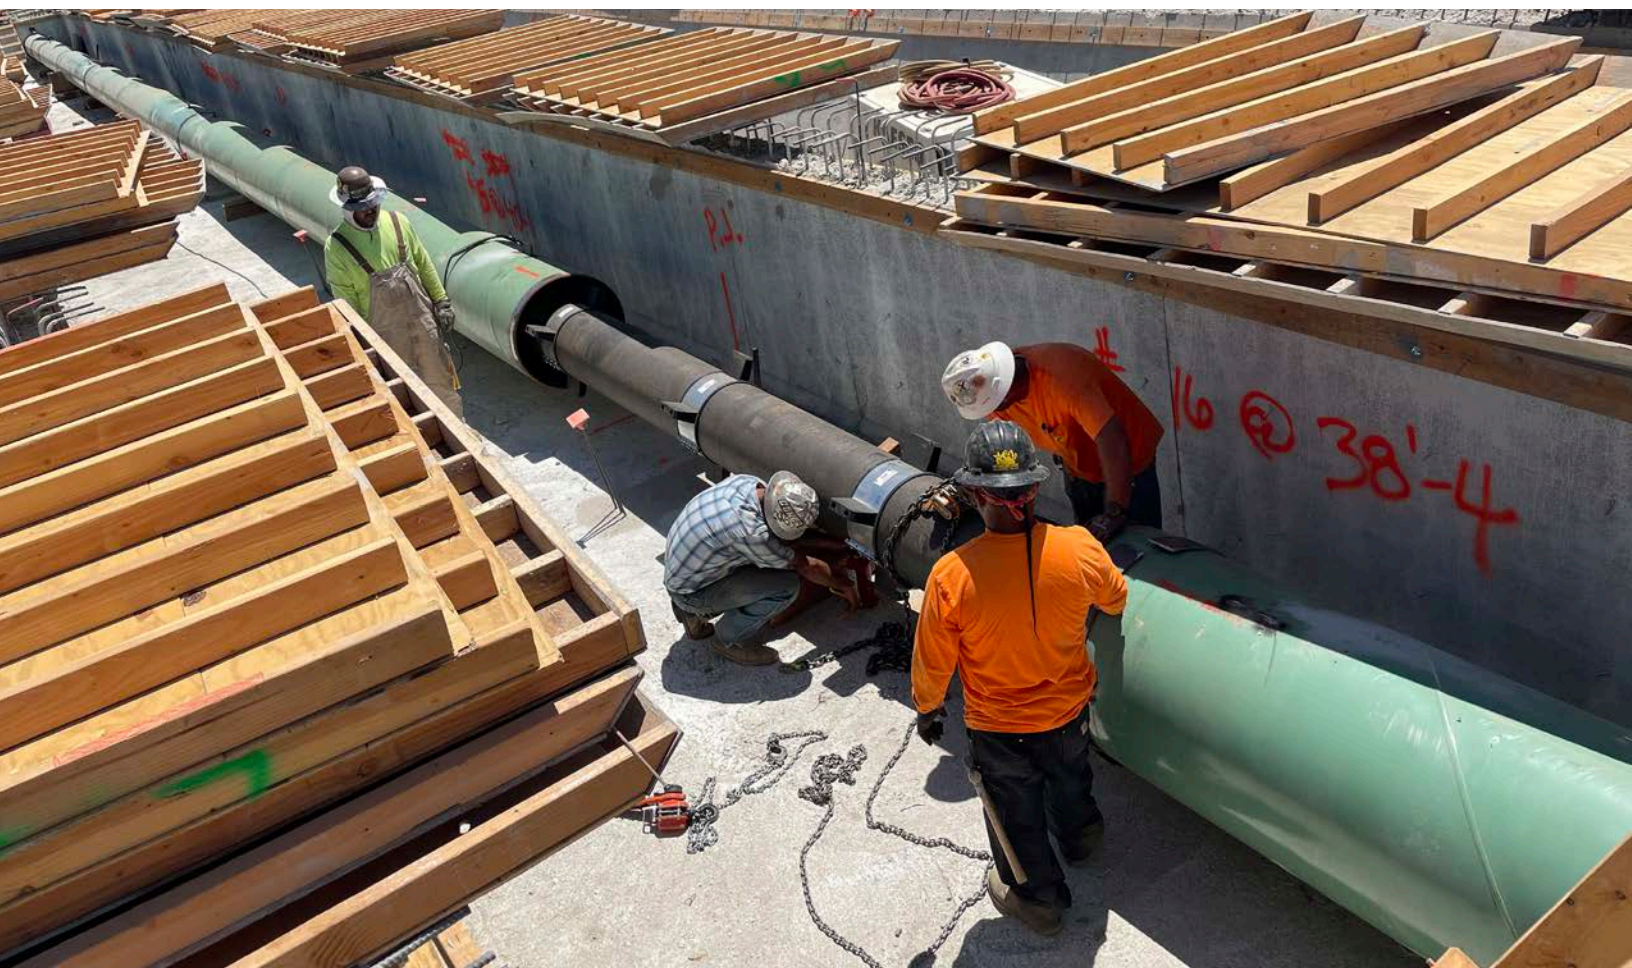
Through a joint agreement between Stanislaus County and the Community of Hickman, the replacement bridge was designed to support this important waterline across the Tuolumne River. The force main was installed in a welded steel pipe casing to protect the surrounding environment and multi-use trail below the bridge from potential damage due to a pipe leak, and to obtain the construction permits from the California Department of Fish and Wildlife, State Lands Commission, and Central Valley Flood Protection Board. **The addition of the 16-inch diameter water force main to this bridge replacement project, significantly improved the reliability of the water system in the Community of Hickman and associated quality of life.**

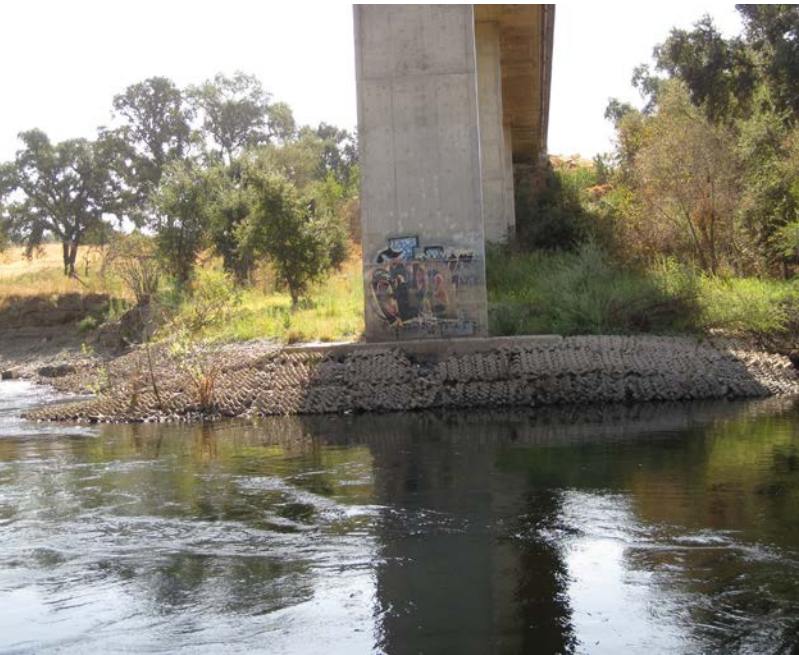
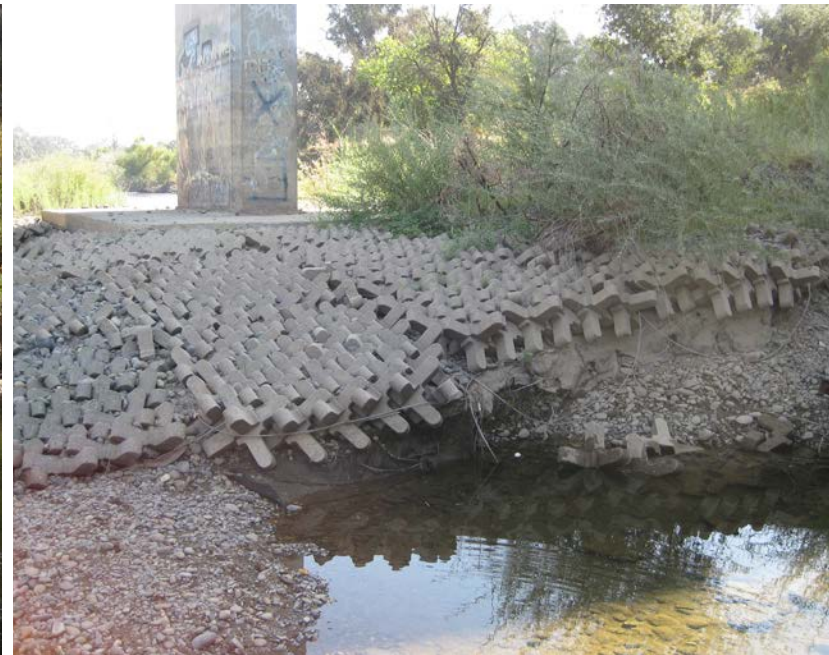
In order to reduce flow velocities of the Tuolumne River through the bridge crossing, longer spans are being used for the replacement bridge to reduce the number of obstructions (piers) within the Tuolumne River channel. The new bridge is a 5-span structure as opposed to the 7 spans of the former bridge. This reduces the total number of piers within the river channel by two thus opening the waterway of the river and slowing down velocities.

To address the 25 feet of scour, the two-column piers of the replacement bridge are supported on deep foundations. Each pier is supported by two large-diameter cast-in-drilled-hole (CIDH) piles, ranging in diameter from 100 inches at

the shorter piers (Piers 2 and 5) to 125 inches at the taller piers (Piers 3 and 4). Each CIDH pile is on the order of 125 to 130 feet in depth so as to be founded well below the total future scour of 25 feet. In addition, the upper 25 feet of soil embedment was neglected in determining the capacity of the CIDH piles and were designed as columns in this region.

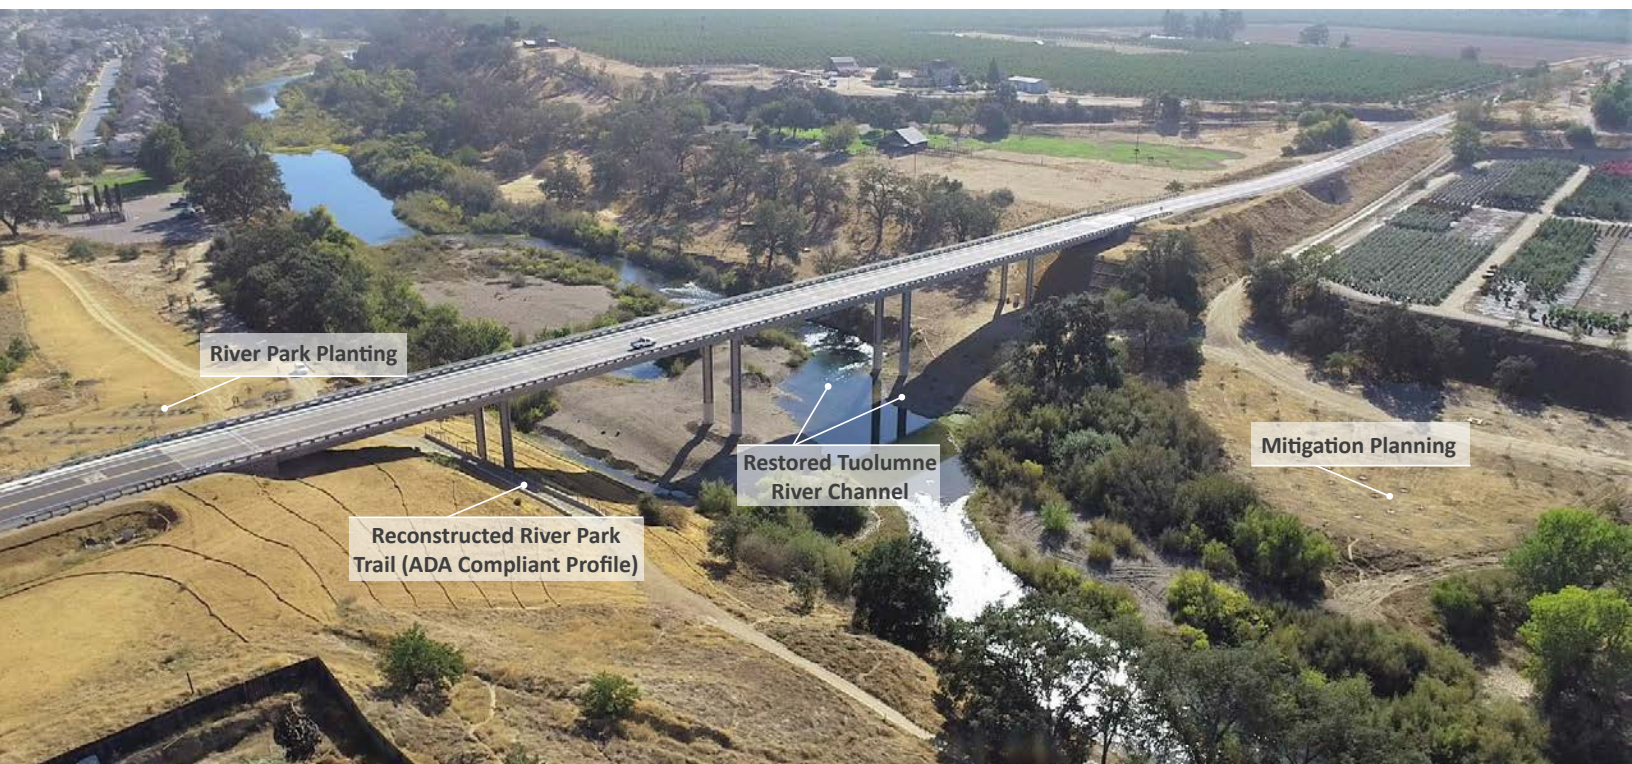
INCORPORATED BAT HOUSES ON THE REPLACEMENT BRIDGE. During the design and environmental clearance effort for this project, it was discovered that roughly 6,000 bats had taken residence on the former bridge, specifically under the east deck overhang, between the bridge’s east exterior girder and the exterior bridge-mounted communication conduits. This led to considerations for how these bats could make the new bridge their home at the completion of construction. Bat houses mounted to both exterior girders of the replacement bridge were incorporated into the design of the new bridge, allowing for ideal roosting conditions – a place where they can give birth to and raise their young. Within a few months after the completion of the new bridge, bats had already begun residing in the new bat houses.

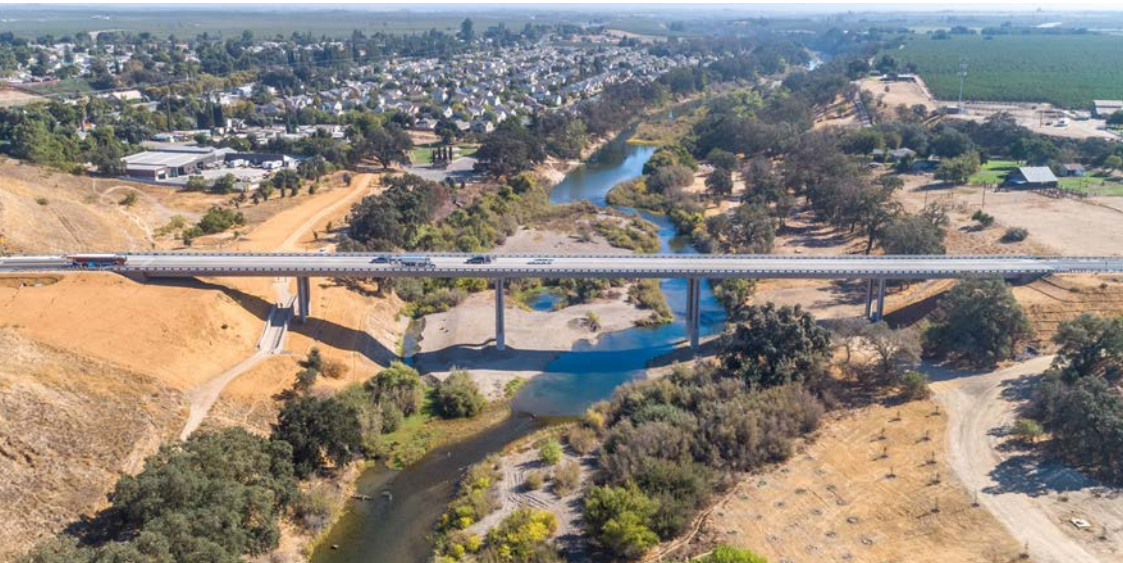
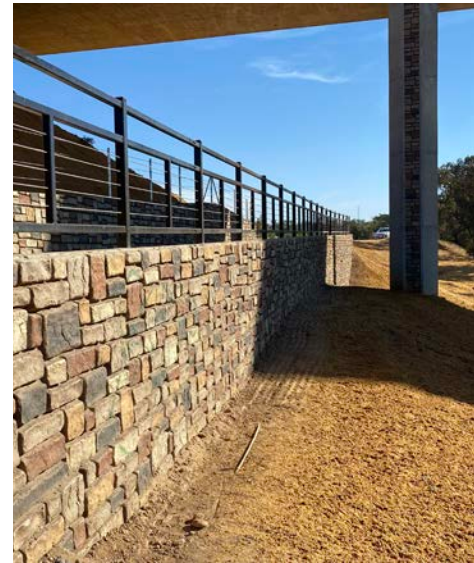
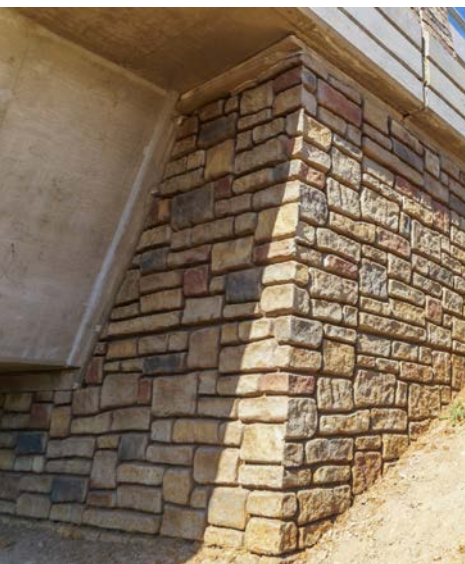
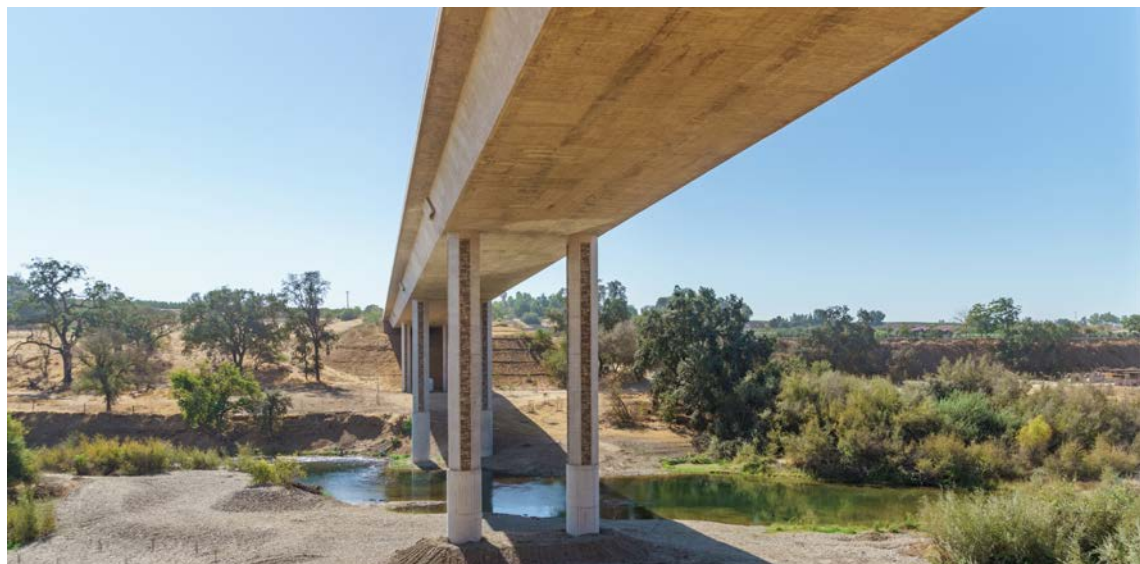
To improve the aesthetics of the park and trail at the bridge location and prevent a concrete monolith, aesthetics were incorporated into the bridge itself and the retaining walls supporting the new ADA compliant trail. A concrete form liner and concrete staining were used to simulate stacked rock and improve the hardscape aesthetics in and around River Park and the River Park Trail.
