NATIONAL TRAILS HIGHWAY 66 HISTORIC BRIDGE PRESERVATION PROGRAM

DOLA AND LANZIT BRIDGES PILOT REPLACEMENT PROJECT PHOTO NARRATIVE

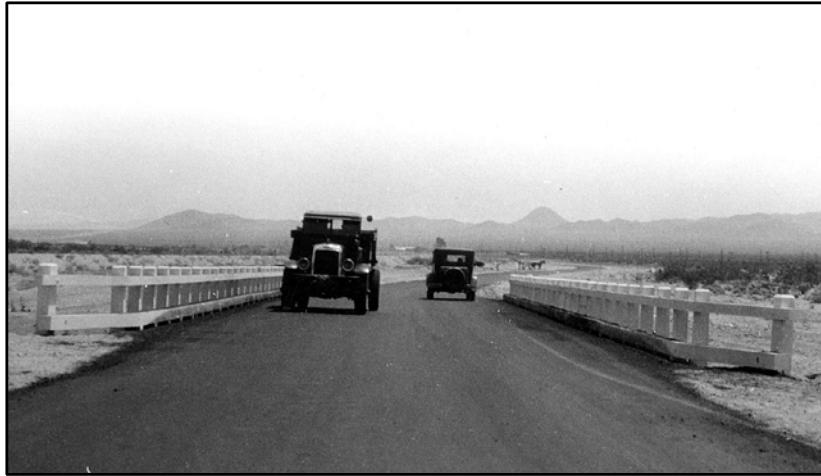
View: 1931 photo depicting typical original 1929-1931 California U.S. Highway 66 Bridge superstructure details include wood railings, curbs, scuppers, and beveled posts. Note, the visual prominence of the original wood railings/guardrails which pop-up to create a “picket-fence” appearance. The original bridges clearly read as wood timber trestle structures, as opposed to the current condition of most of the existing bridges which have cut- down wood bridge posts.

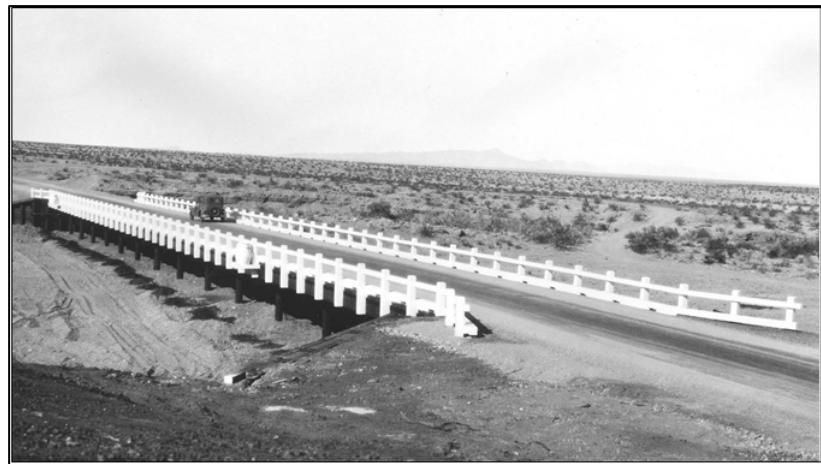
View: Depicting virtually all major timber trestle bridge substructure and superstructure components. Substructures include wings and bulkheads (abutments), pilings, caps, and attachment of superstructure to substructure. Superstructure details include interior and exterior views of wood railings, and exterior view of flared railings.

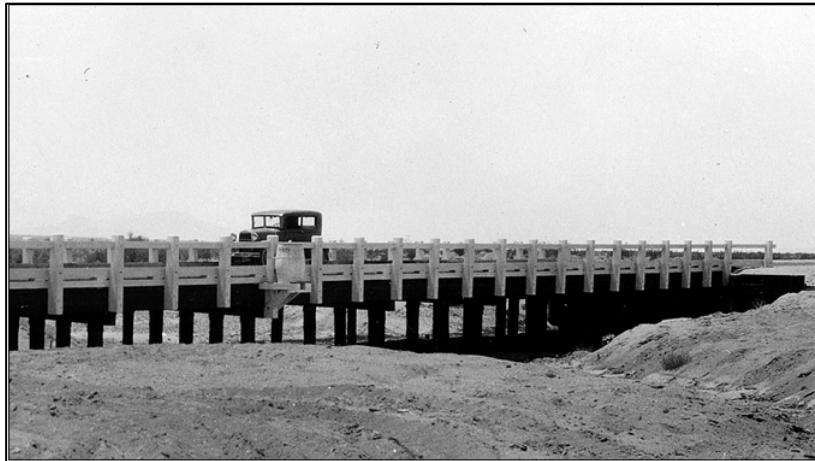
View: Showing substructure details including flat wings (wingwalls) bridge pilings in wash, caps, beams, and connection of bridge guardrail posts to caps and fascia. Superstructure details include original wooden fire/water barrel and original guardrail height as compared to automobile. The “picket fence” appearance of the 1931 timber bridge is visually prominent.

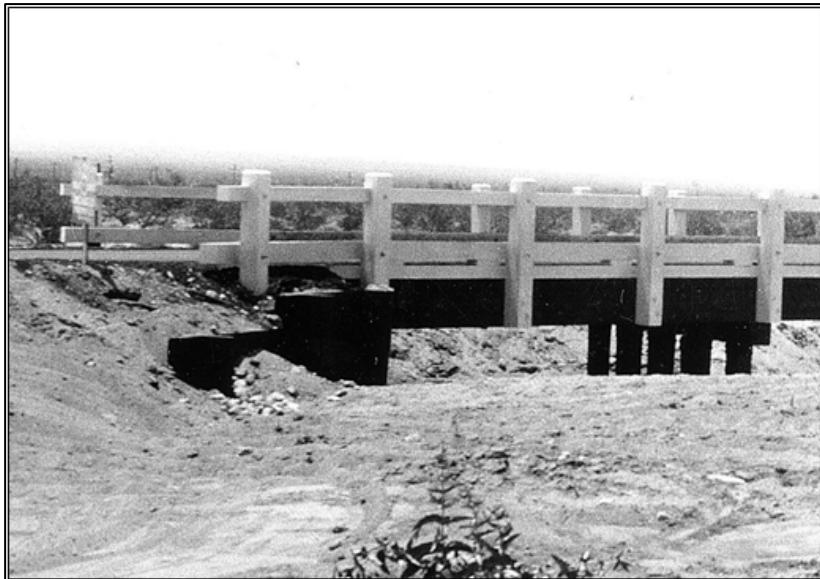
View: Substructure details including slant wings (wingwalls) and pilings, bridge pilings in wash. Superstructure details include interior and exterior views of wood railings, and exterior view of flared railings.
